**SECTION 31**

## CONFIGURATION CHANGES AND CERTIFICATION STATUS

Orbiter 01/09/03

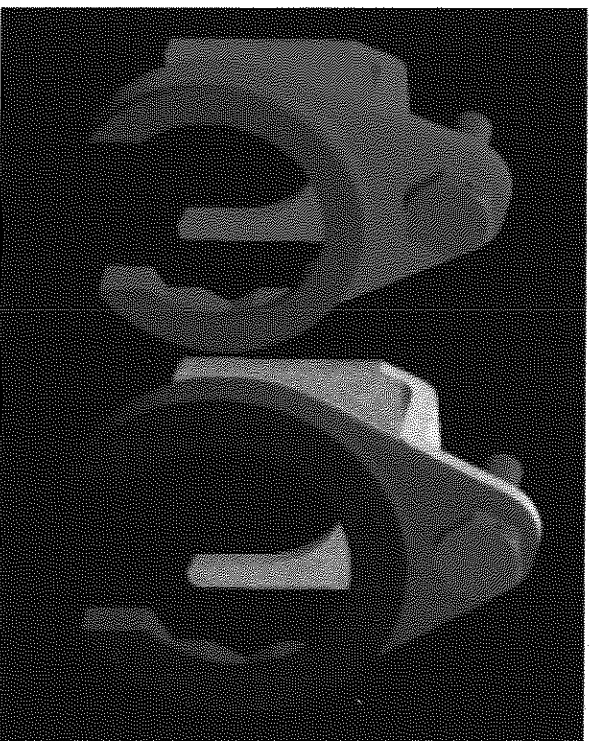
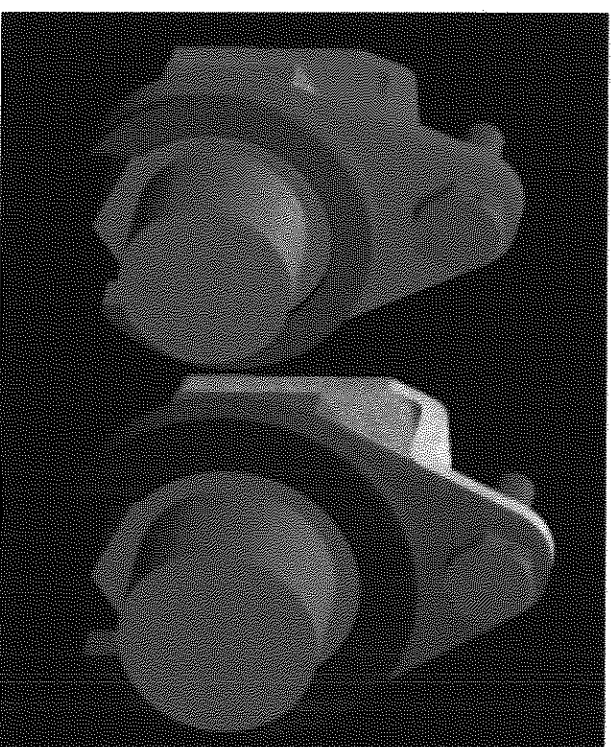
### FRCS Dynatube B-nut Retainers Installed by MR: (Cont)

Approximate Dimensions: 2" height

1.5" width

0.65" depth

Weight of Assembly: 1.8 oz oxid, 1.45 oz fuel

Material: CRES 304

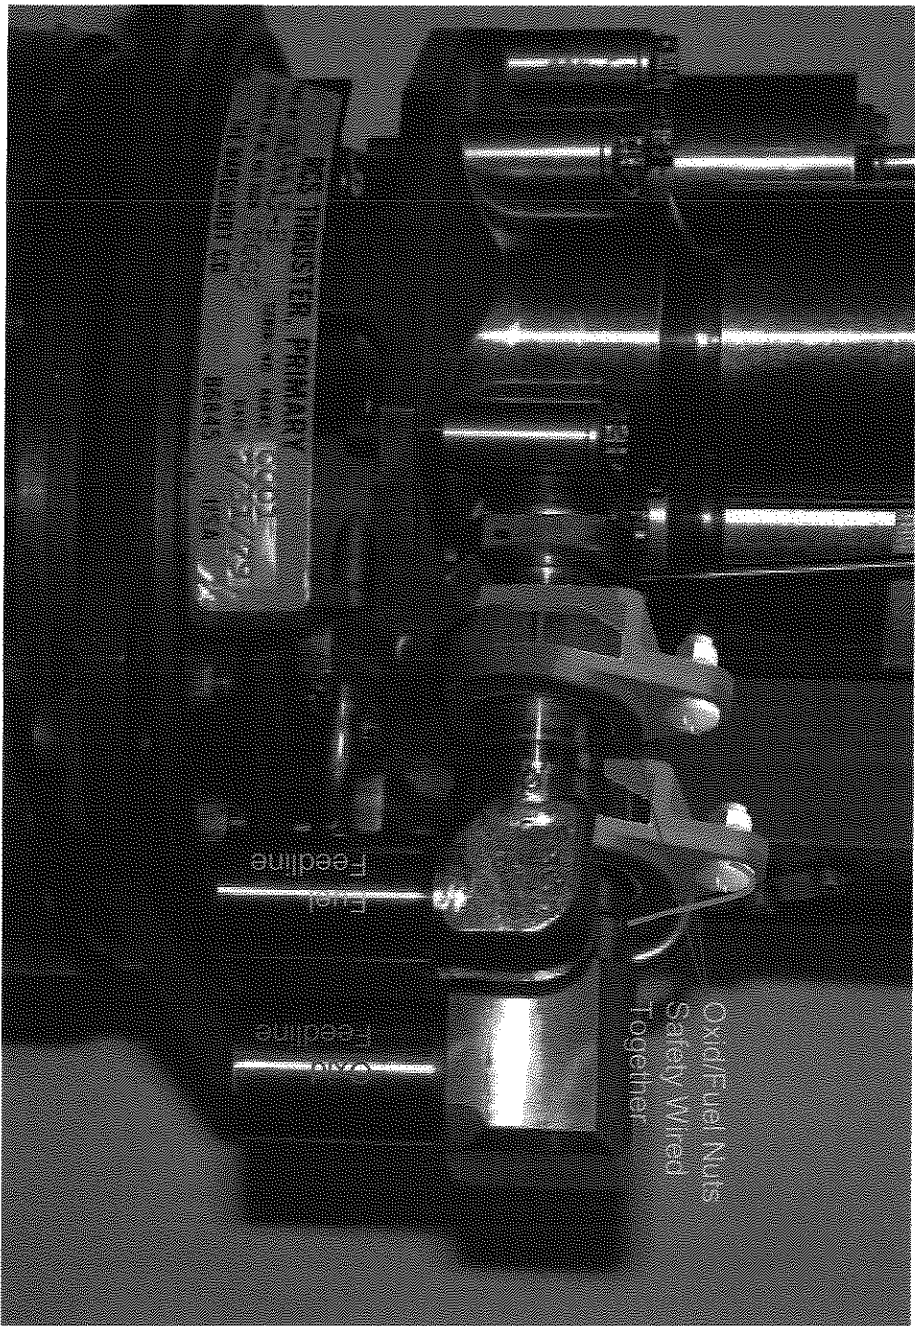
## FRCS Dynatube B-nut Retainers Installed by MR: (Cont)

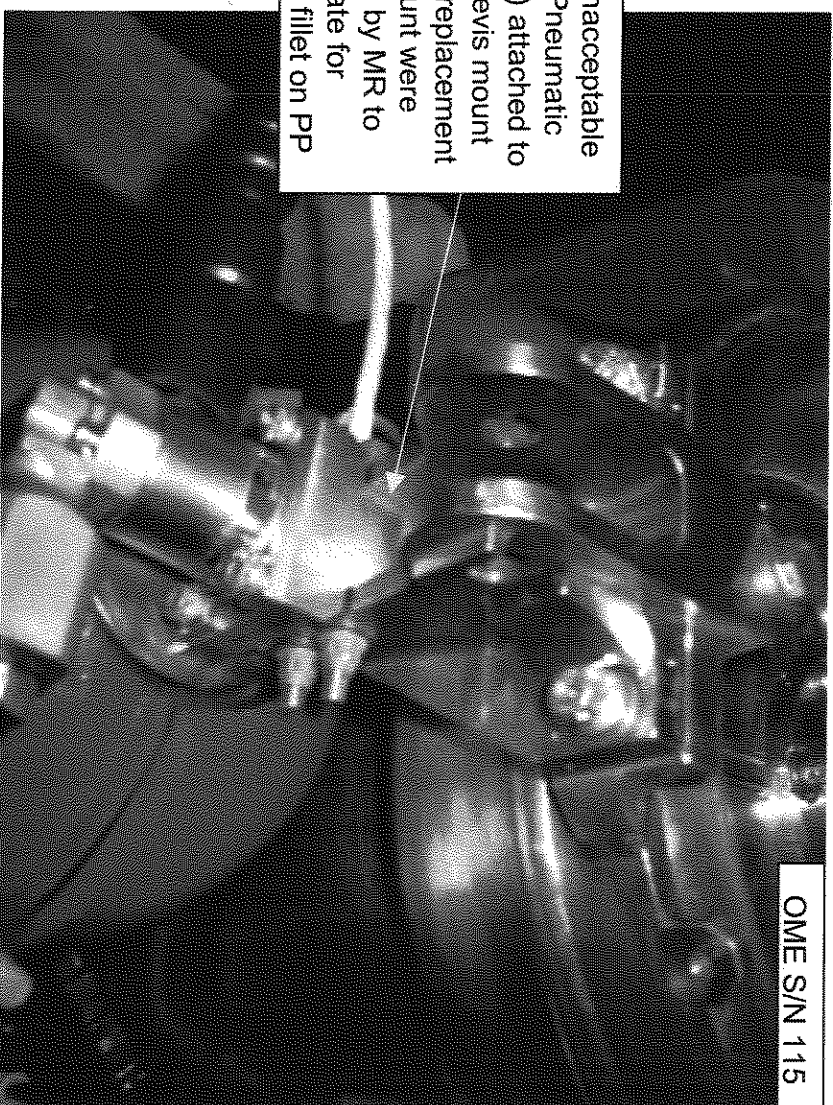
OME S/N 115

- Original clevis mount on Orbital Maneuvering Engine (OME) S/N 116 not manufactured per print
  - The area where the pneumatic pack bracket attaches via two thru-bolts was inadvertently machined ~.021" oversize
  - PRT recommended replacement due to concerns with excessive play in the pneumatic pack bracket attachment and thinning of the clevis where it was machined
  - Replacement part was obtained from WSTF
- With new clevis mount installed, the pneumatic pack could not be attached due to misalignment of the bolt holes
  - Pneumatic pack attach structure also not per print - fillet radius too large, causing clevis mount tangs to contact fillet before bolt holes are in alignment

### OME Pitch Clevis Mount (Actuator Not Installed)

- Area of unacceptable gap with Pneumatic Pack (PP) attached to original clevis mount
- Tangs of replacement clevis mount were machined by MR to compensate for oversized fillet on PP

- Plan was developed to machine clevis tangs to compensate for oversized fillet (chamfer 0.08" off edges)
- Boeing/JSC Stress verified integrity of the clevis mount is not adversely affected
  - Chamfer does not protrude into bolt holes
- Measurements of both the removed part and the replacement part verified acceptable difference in pitch actuator mounting hole location without adjustment of actuator
- Travel and Response and Heat Shield Clearance checks were performed during OMS/RCS Flight Control Checkout (OMI V1238) with no anomalies

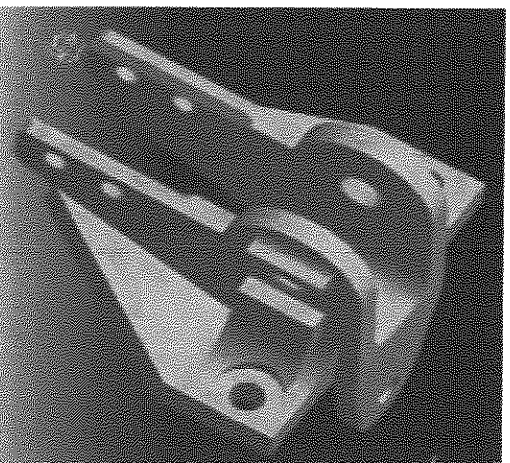
## Modified (Chamfered) OMS Engine Pitch Clevis

Top view of pitch clevis modification  
OMS engine S/N 116
